Eyes on Tung Chung Stream Restoration

Progress of reinstatement

Recommendations on the Reinstatement Design of the Impacted Section of Tung Chung Stream downstream of Shek Mun Kap (by Dr. Alan Leung)

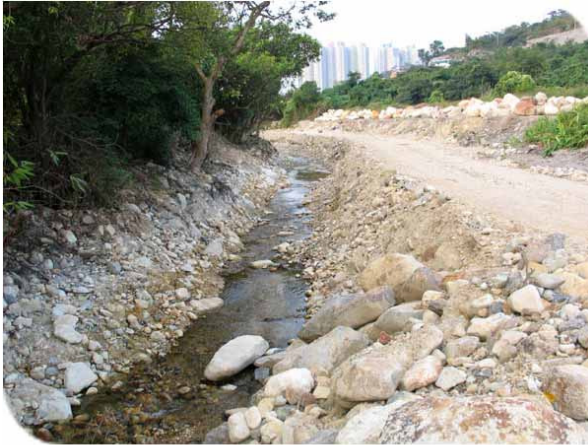
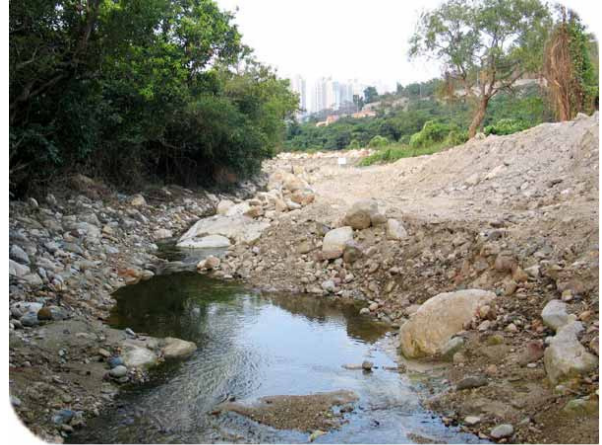
21 November 2003

Our first site visit on Tung Chung Stream after devastation. Please note that a haul road was built on one side of the stream for the access of construction vehicles. The stream was narrowed and straightened. The streambed boulders were also removed and stockpiled on the streamside.

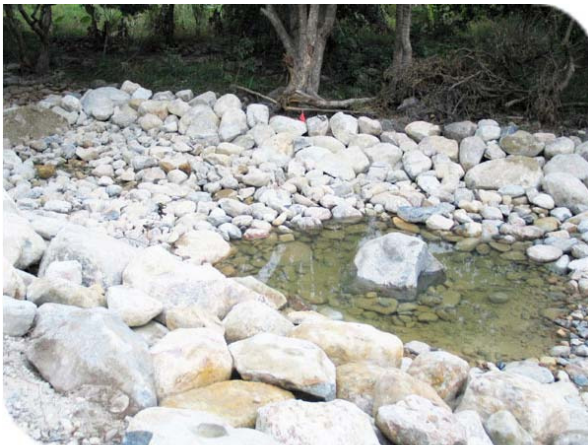
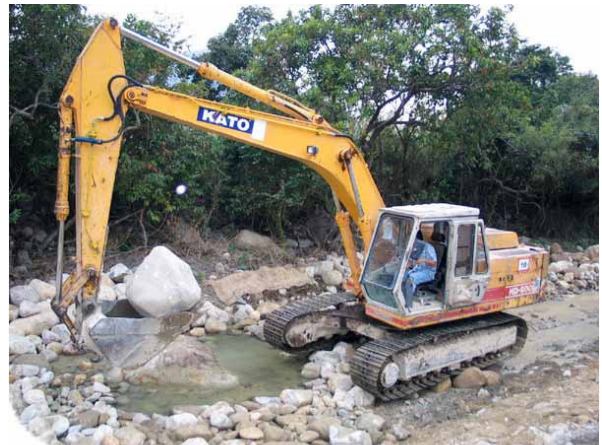
22 & 23 February 2004

After one week of restoration work, about 10 metres of the stream restoration work had been done. However, the pools were somewhat unnatural in appearance and the cobble layers in the riffle sections were too thick. There were also inadequate big boulders randomly placing on the streambed. Comments were given on-site and the contractor was following the recommendations from the Specialist Group to re-shape the stream channel.

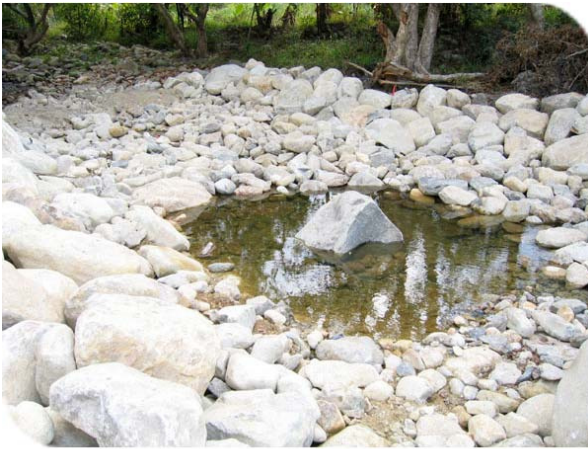
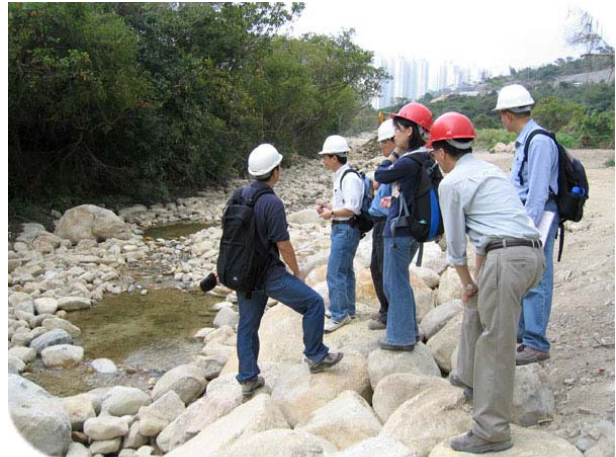
1 March 2004

About 60 metres of the stream had been done. With the experience of from the first 10 metres and the implementation of the requirements suggested by Specialist Group, the restored stream channels were more resembled to a natural stream. Nevertheless, the Specialist Group did provide some further suggestion, such as the positioning of big boulders to facilitate the formation of pools and the reduction of silt downstream of the work site.

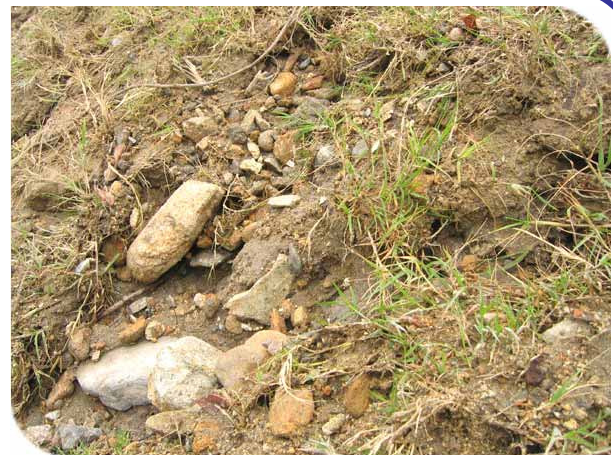
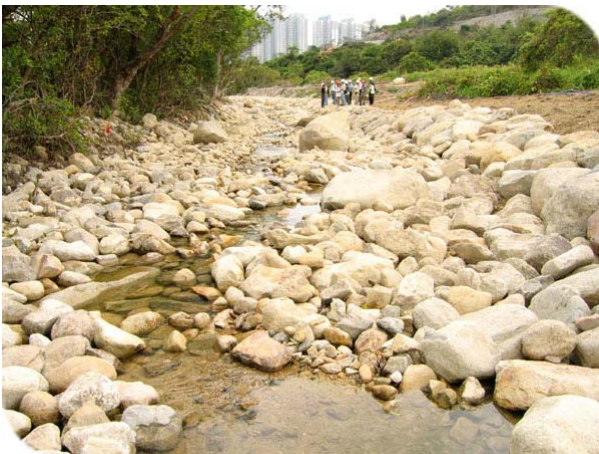
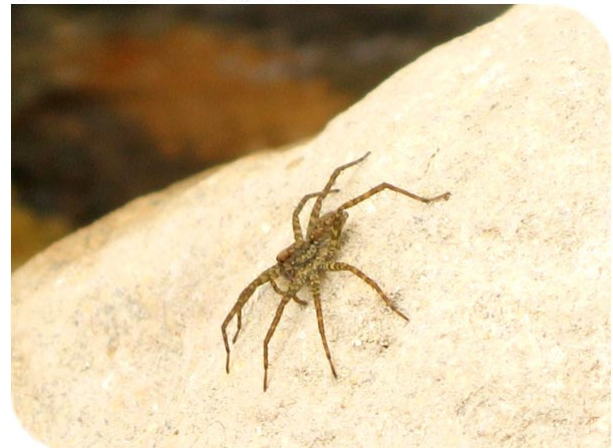
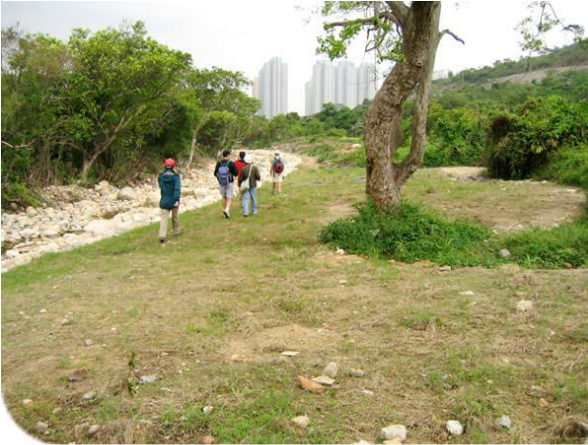
12 March 2004

About half of the devastated stream being restored. The restoration work was generally acceptable, however, the installation of big boulders on and the meandering of the stream channel were inadequate. At the same time, grass was planted on the exposed soil beside the restored stream channel to reduce soil erosion. Some organisms were observed at the restored stream section, including fish (e.g. Half-banded Barb & Swordtail), and spider (*Pisauridae*).

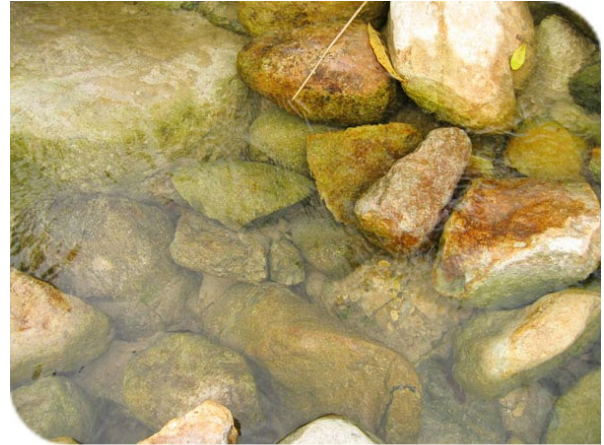
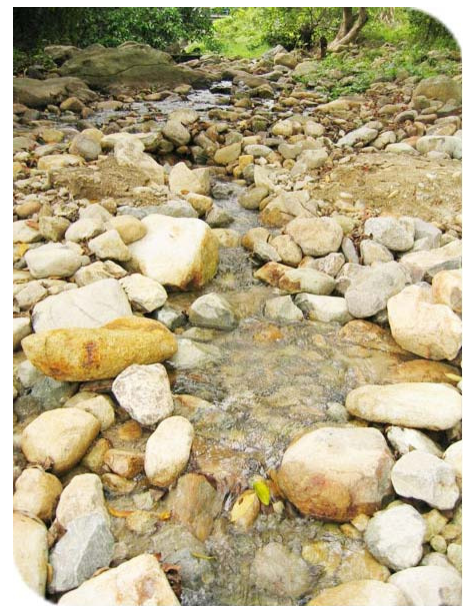
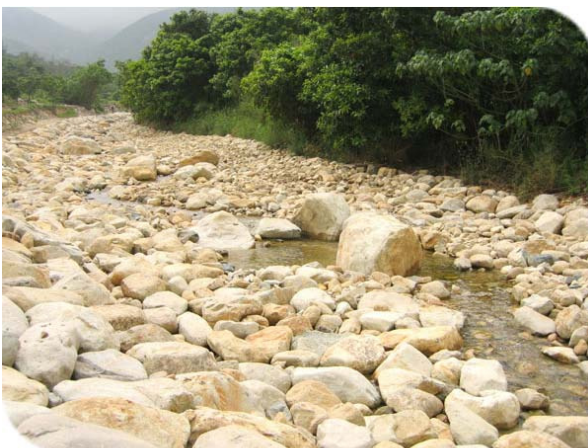
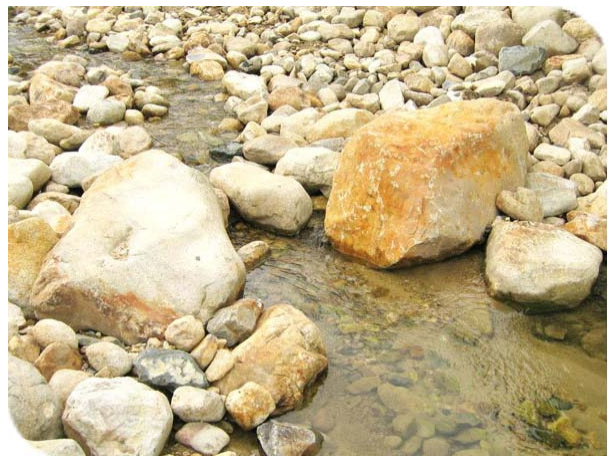
1 April 2004

The restoration of the Tung Chung Stream has been completed.

- the stream bank and streambed have been stabilized using natural rock particles;
- instream structures, including pools and riffles, have been rebuilt;
- some riparian vegetation, mainly have been replanted or seeded;
- the haul road has been removed; and
- the stream profile and setting is somewhat resemble to pre-disturbed condition.

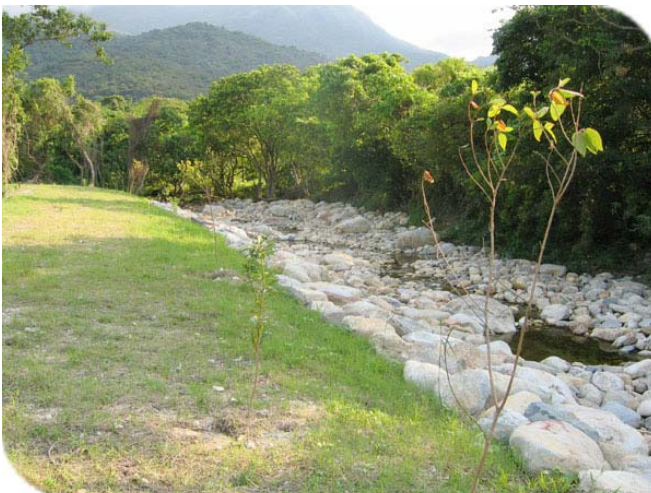
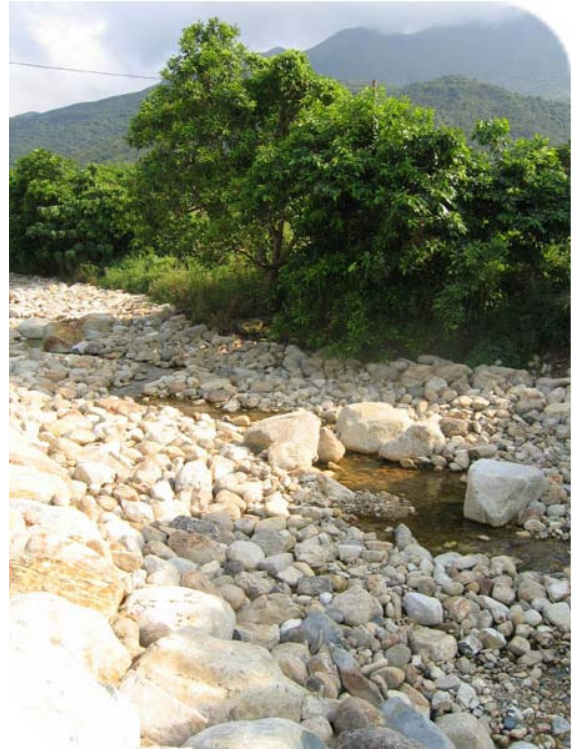
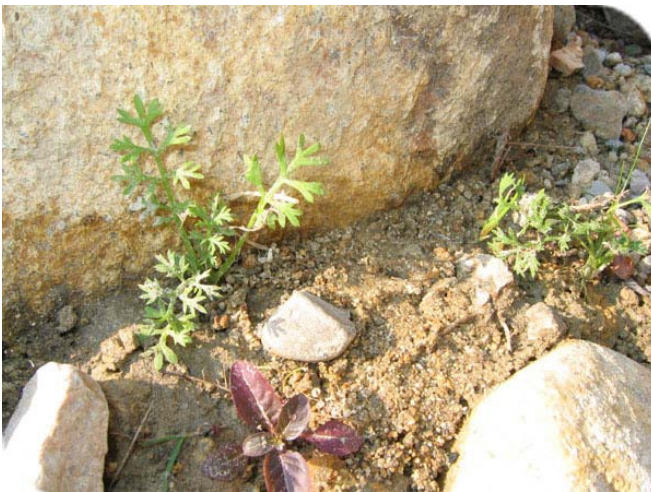
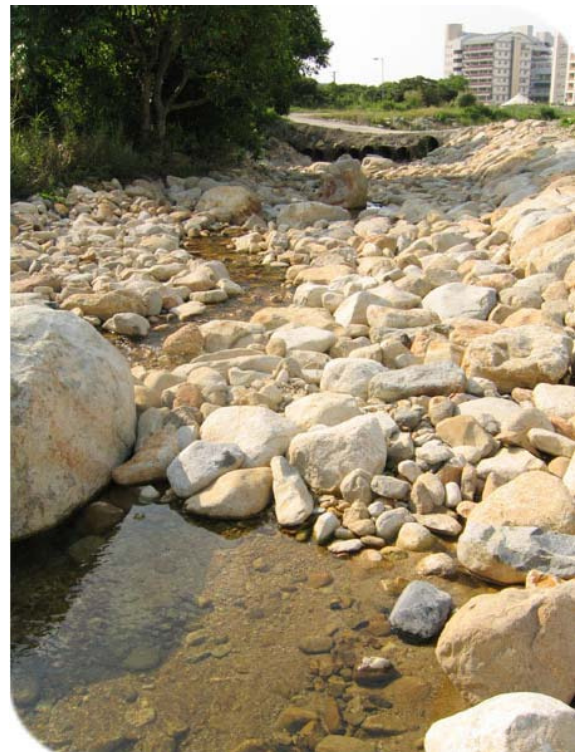
29 April 2004

After one month of completion, the environmental conditions of the restored Tung Chung Stream is improving steadily, with the formation of various habitats including sand and leaf litter patches in addition to pools and riffles. By field observation, three species of fish (*Parazacco spiliurus*, Half-banded Barb & Swordtail) and two species of damselfly adults (*Neurobasis chinensis* & *Rhinocypha perforata*) were found. Sampling of benthic invertebrates found that a few species of pioneer insects, including mayfly larvae (*Liebebiella vera* and *Baetis* sp.) and Chironomids, dominated the stream benthic communities.

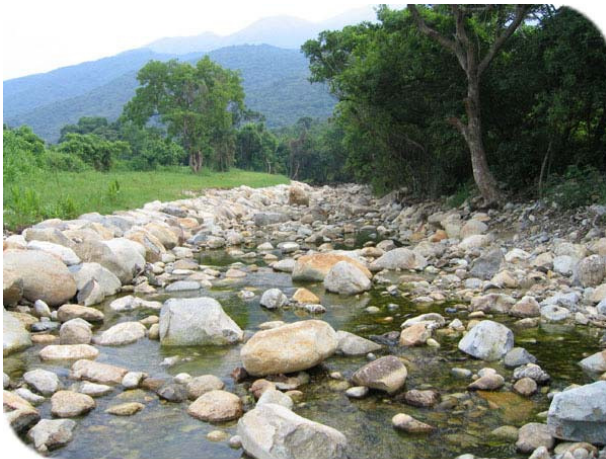
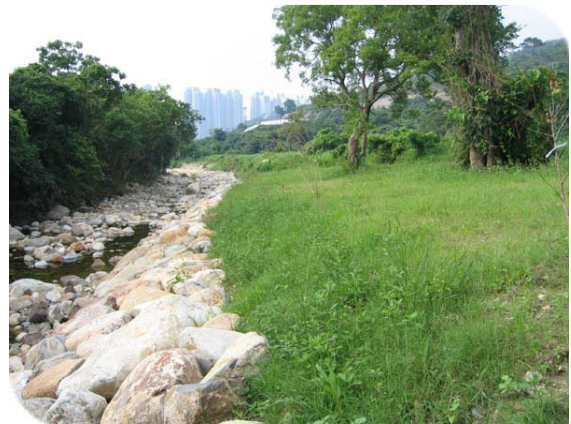
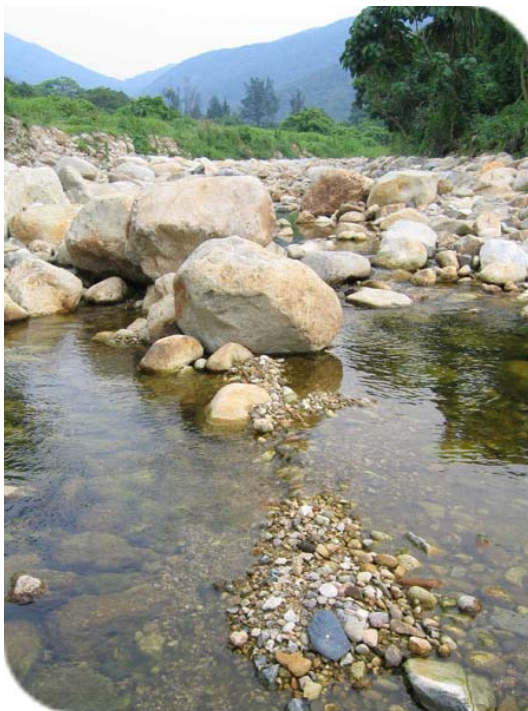
27 May 2004

The stream outlook has changed considerably with the sizes and locations of pools and riffles looked rather different from before! Such modification of the stream setting were possibly induced by the intensified rainfall on 8 May 04, which near 200 mm of rainfall was recorded around the Tung Chung Stream drainage basin. The nature seems trying to re-shape the stream by itself to makes it more "natural".

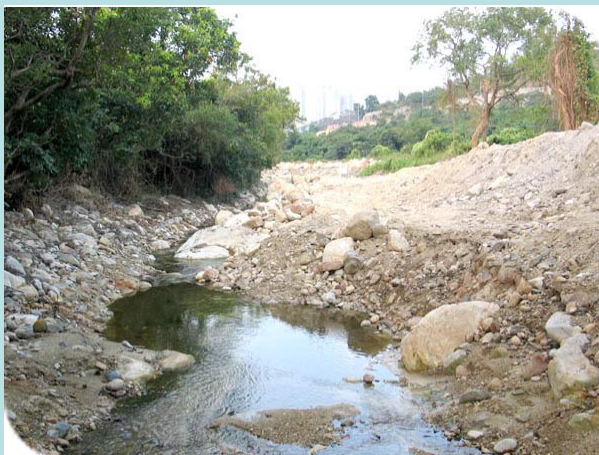
According to my field visit made on 21st November, 2003, the affected section of streams was dominated by sandy substrate. The stream bank on the side between the stream and Tung Chung Road was highly unstable, which were mainly formed by loosely placed cobbles, with all the riparian vegetation removed. Such environment provides no refuges for stream organisms, including fishes, particularly during the period of high water flow after heavy rains. The small sized substrate particles (sand and cobbles) would also be easily carried downstream during high stream flow, directly affecting the downstream Drainage Service Department channelized section of Tung Chung Stream.

The destroyed River section downstream of Shek Mun Kap

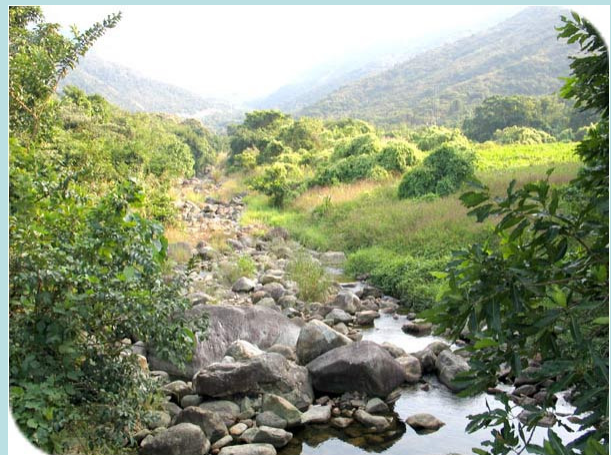
Natural undisturbed section upstream of Shek Mun Kap.
